SUMMARY
 1234 Main Street Tigard OR 97223
 Buyer Name
 02/01/2024 9:00AM

McLean Bergin
 Hartwell Home Inspections llc
 5034572491
 macbergin1027@gmail.com

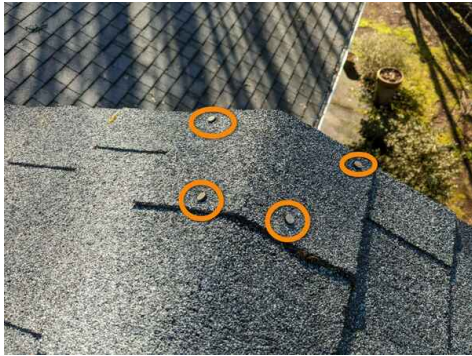
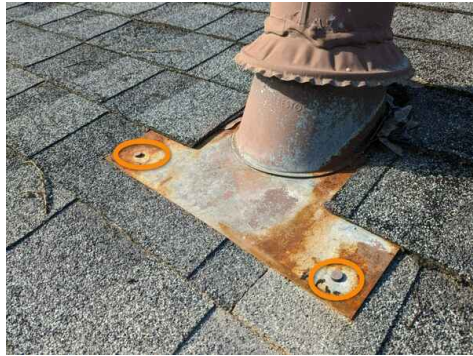
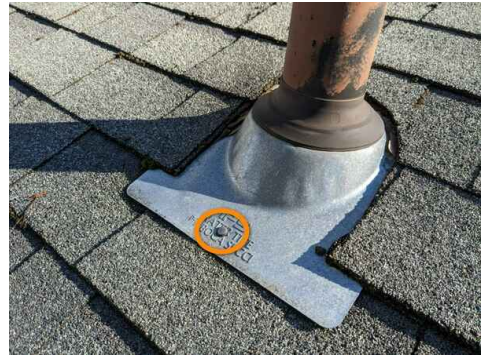
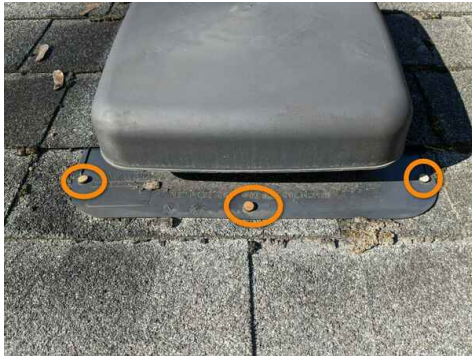
2.1.1 Roof Covering
EXPOSED FASTENERS

Major Defect

I observed indications of exposed fasteners at the roof-covering materials. Fasteners should not be exposed. Potential water entry points. Roof could leak. Further evaluation and correction is recommended.

Recommendation
 Contact a qualified roofing professional.

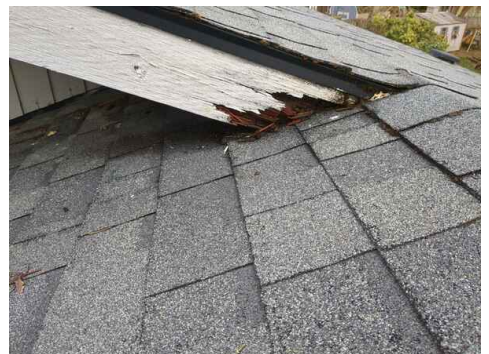
3.2.1 Eaves, Soffits & Fascia
DAMAGE OBSERVED AT FASCIA

Major Defect

I observed indications that one or more areas of the fascia were damaged.

this is above the front entry way where the fascia meets the peak of the garage

Correction and further evaluation is recommended.

Recommendation
 Contact a qualified general contractor.

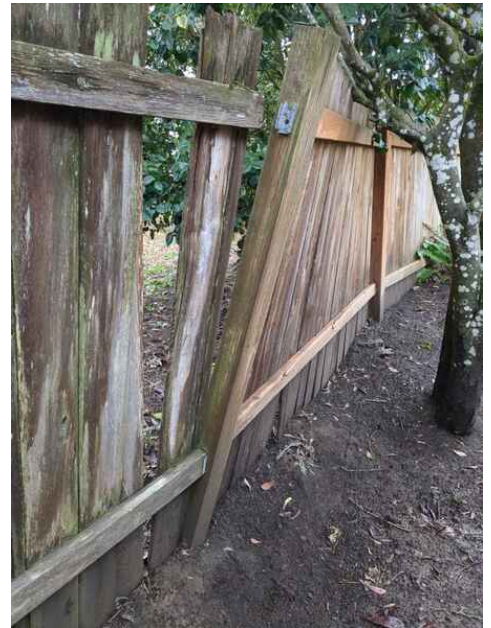
3.4.2 Vegetation, Surface Drainage, Retaining Walls & Grading
FENCE DEFECT

Major Defect

I observed that the condition of the fence in many areas is poor.

Recommendation
Contact a qualified fencing contractor

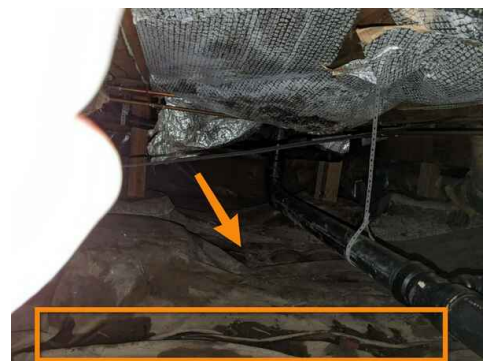
4.1.1 Under-Floor Crawlspace
PRIOR WATER PENETRATION OBSERVED

Major Defect

I observed indications that sometime in the past, there was water penetration or intrusion into the crawlspace.

Correction and further evaluation is recommended.

Recommendation
Recommend monitoring.

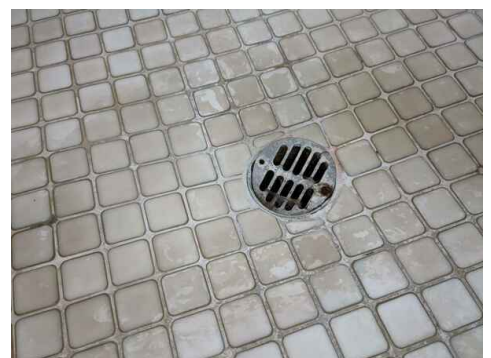
10.2.1 Sinks, Tubs & Showers
LOOSE DRAIN COVER

Major Defect

cover for shower drain was loose, could allow debris to enter and cause a clog or be a tripping hazard. recommend repair

Recommendation
Contact a qualified professional.

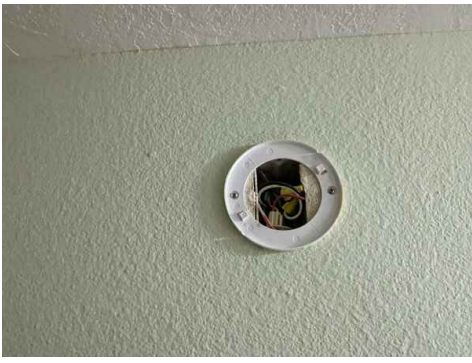
11.7.1 Presence of Smoke and CO Detectors
MISSING SMOKE DETECTOR
HALLWAY

Major Defect

I observed indications of a missing smoke detector. Hazard.

Recommendation
Contact a qualified professional.
