HARTWELL HOME INSPECTIONS LLC

1234 Main Street
Tigard, OR 97223

02/01/2024 9:00AM

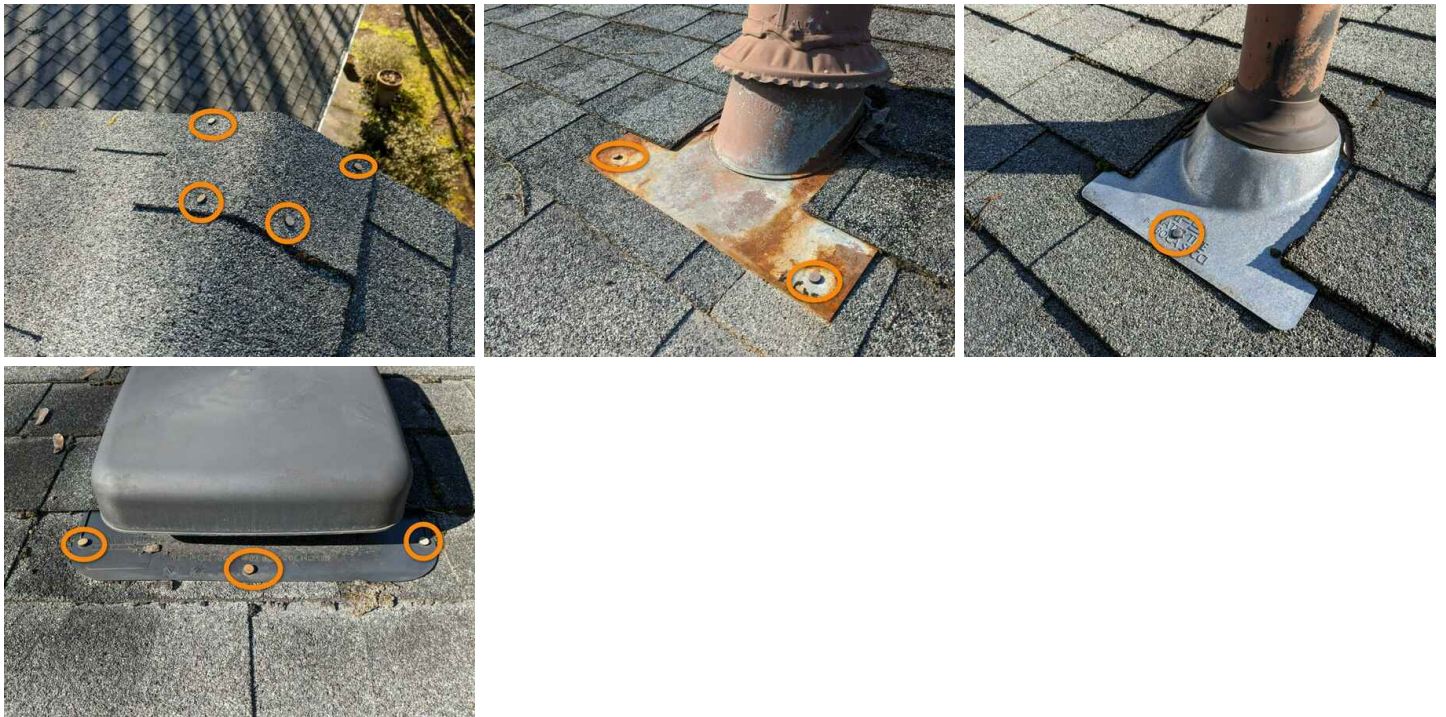
I observed indications of exposed fasteners at the roof-covering materials. Fasteners should not be exposed. Potential water entry points. Roof could leak. Further evaluation and correction is recommended.

Contact a qualified roofing professional.

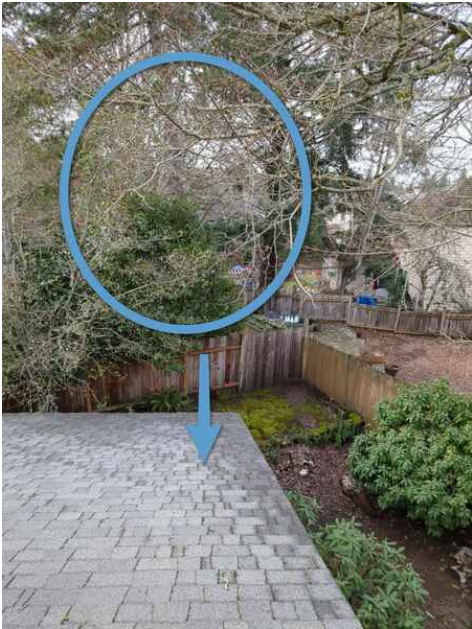
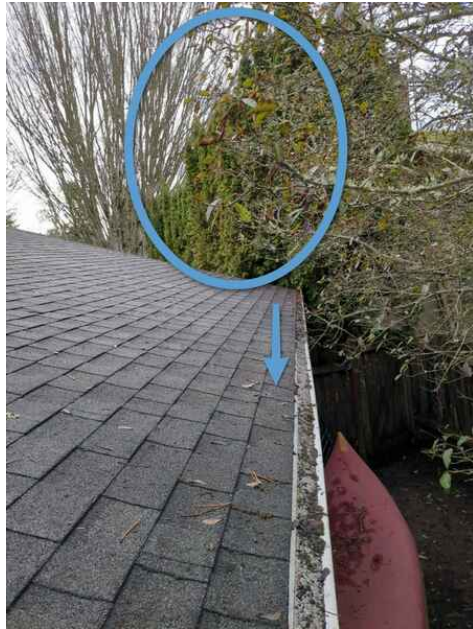
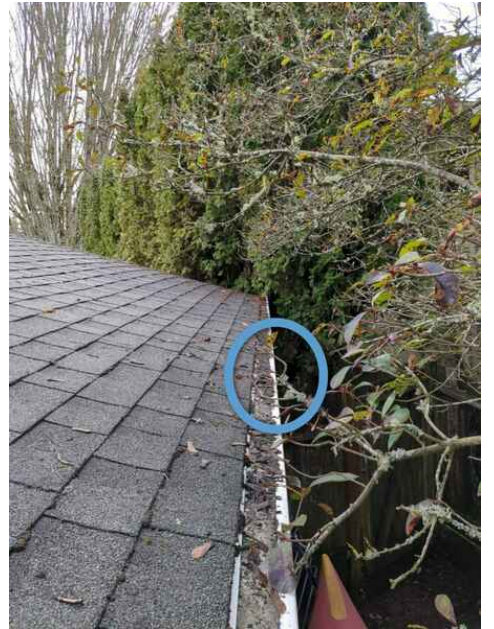
2.1.2 Roof Covering

I observed indications that a tree and or tree branch where overhanging the roof and maybe in contact with it.

Contact a qualified tree service company.

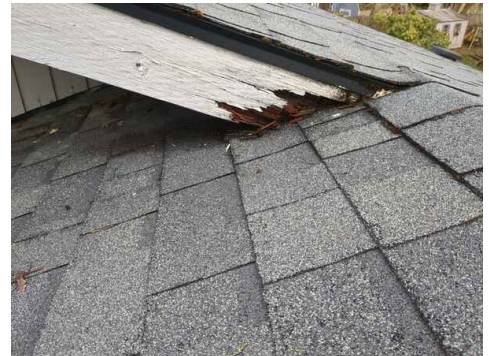
DAMAGE OBSERVED AT FASCIA

I observed indications that one or more areas of the fascia were damaged.

this is above the front entry way where the fascia meets the peak of the garage roof.

Correction and further evaluation is recommended.

Contact a qualified general contractor.

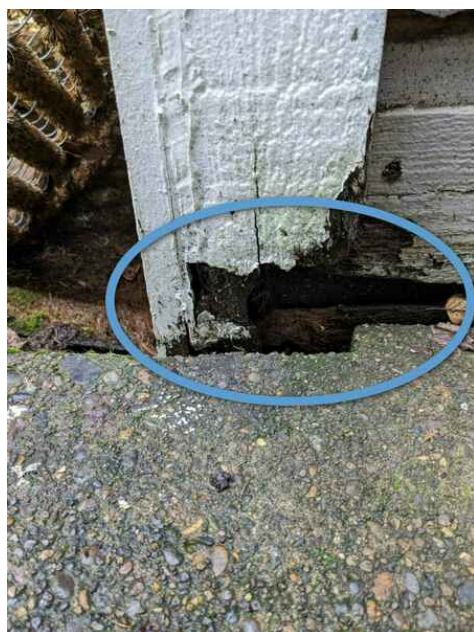
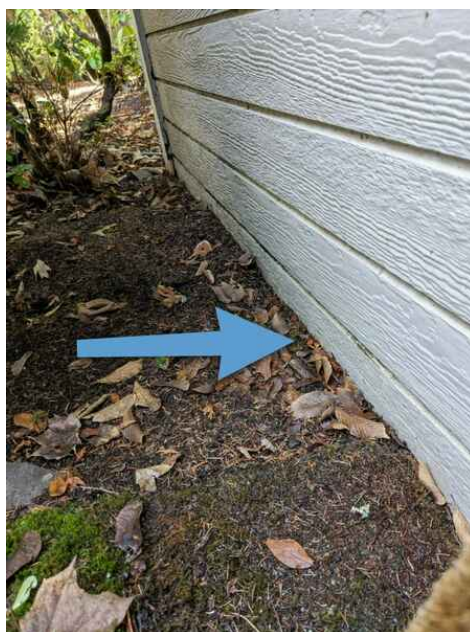
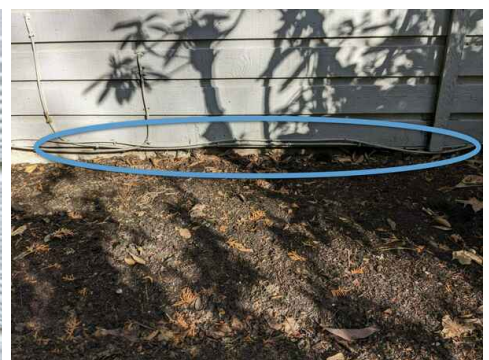
3.3.1 Wall-Covering, Flashing & Trim

INADEQUATE GROUND CLEARANCE

this is at the entry way just to the left of the front door

Correction and further evaluation is recommended.

Contact a qualified siding specialist.

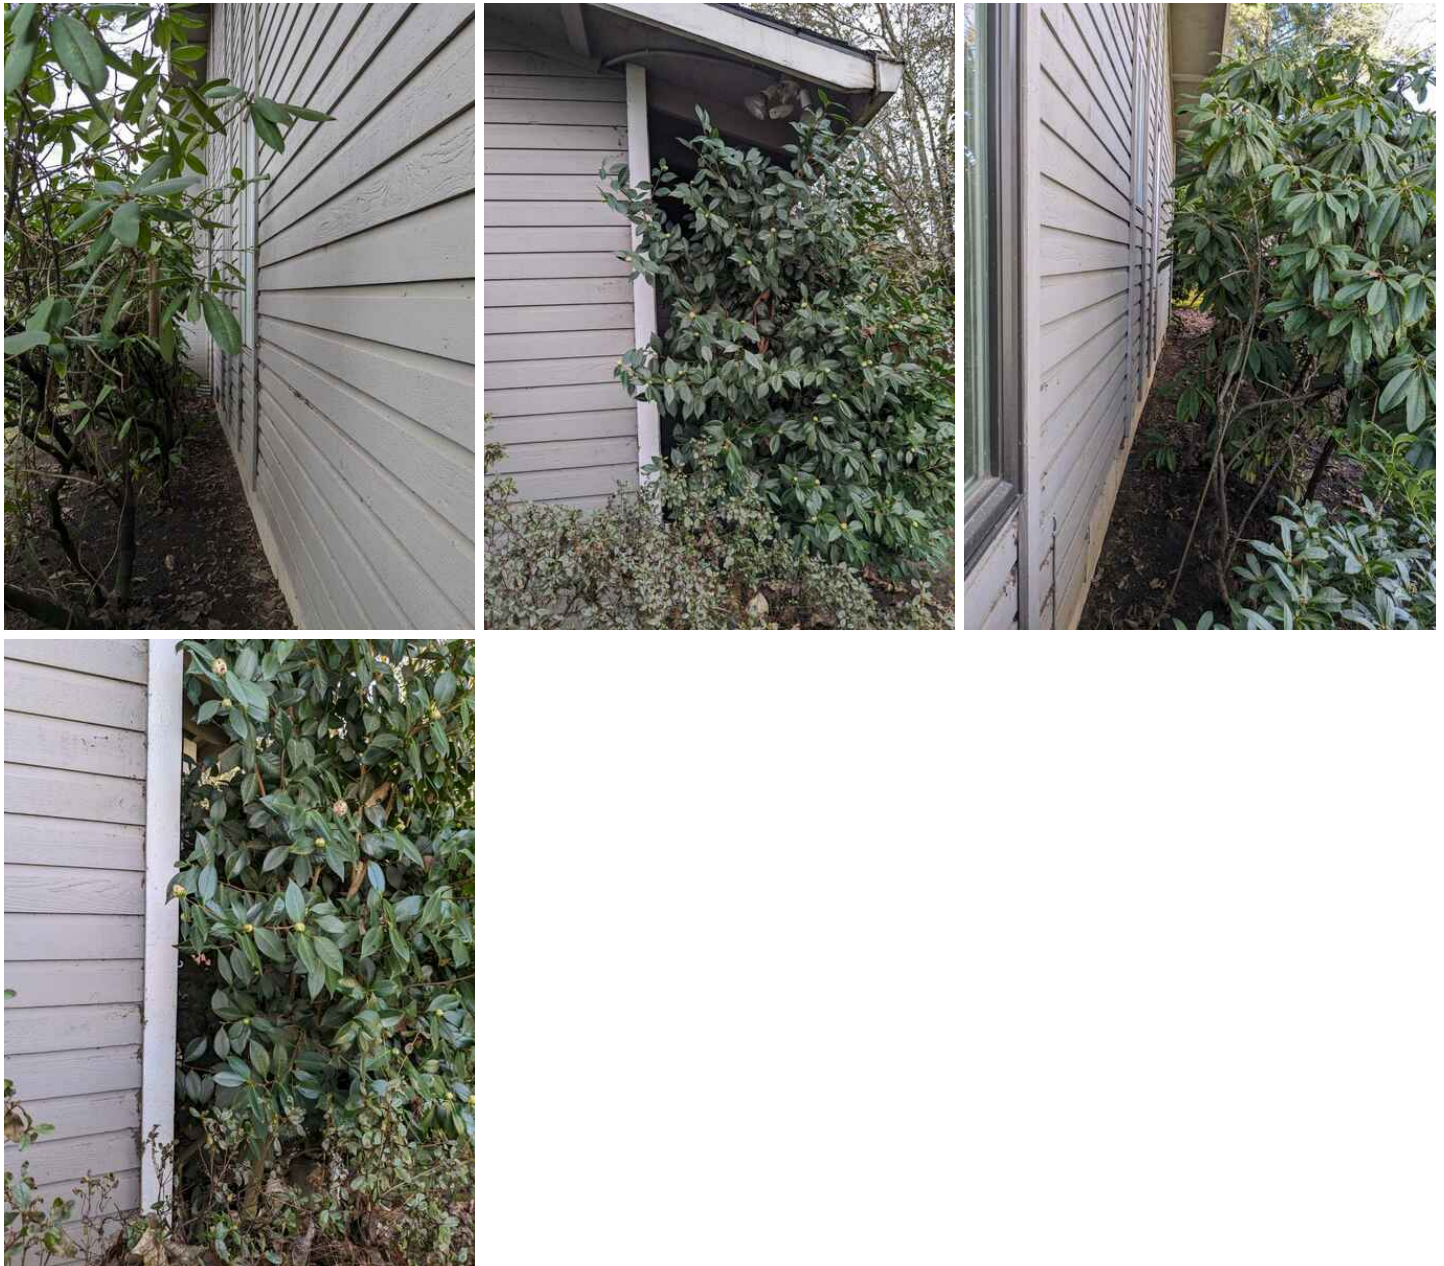
3.4.1 Vegetation, Surface Drainage, Retaining Walls & Grading

I observed dense vegetation around the house in areas. This condition limited and restricted my visual inspection. Dense vegetation and landscaping up against or near the house foundation and exterior walls may be prone to water penetration and insect infestation.

Trimming, pruning and some landscaping is recommended.

Recommended DIY Project

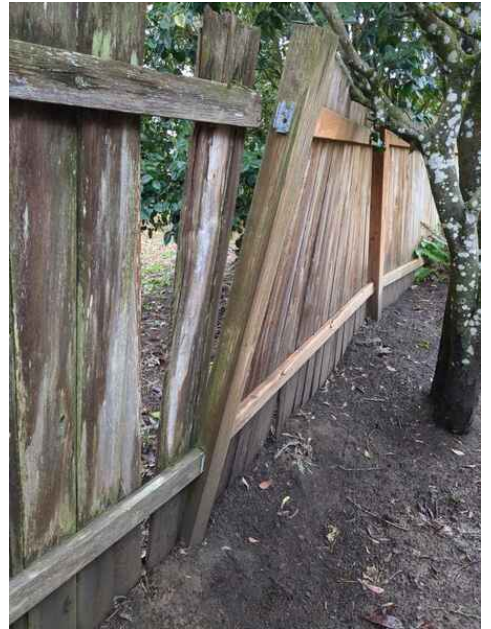
3.4.2 Vegetation, Surface Drainage, Retaining Walls & Grading

FENCE DEFECT

I observed that the condition of the fence in many areas is poor.

Contact a qualified fencing contractor

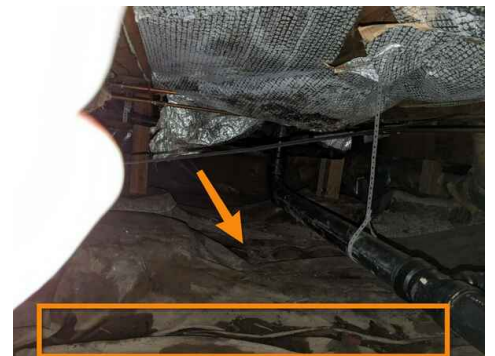
PRIOR WATER PENETRATION OBSERVED

I observed indications that sometime in the past, there was water penetration or intrusion into the crawlspace.

Correction and further evaluation is recommended.

Recommend monitoring.

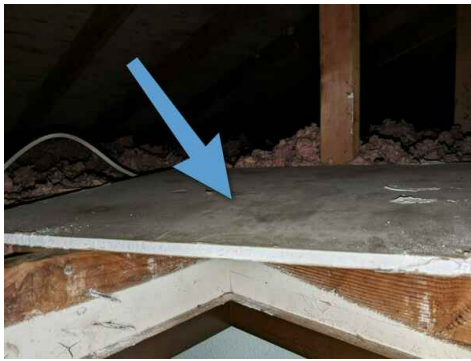
I observed indications that the access to the attic was not insulated and sealed properly. This condition will create a heat/energy loss area. Adding insulation and air sealing at the attic access is recommended.

missing insulation

Recommended DIY Project

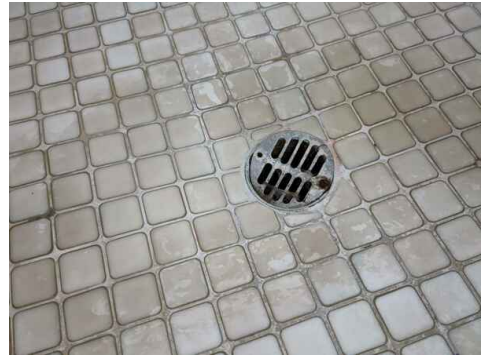
10.2.1 Sinks, Tubs & Showers

**LOOSE DRAIN COVER**

cover for shower drain was loose, could allow debris to enter and cause a clog or be a tripping hazard. recommend repair

Contact a qualified professional.

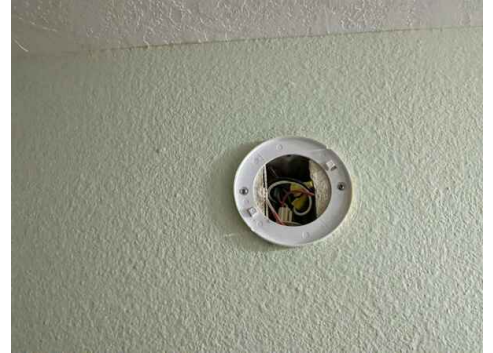
MISSING SMOKE DETECTOR

I observed indications of a missing smoke detector. Hazard.

Contact a qualified professional.
